TREE REPORT

Pico Canyon Park

Los Angeles County is preparing to install a new stormwater infiltration system in Pico Canyon Park. This park includes a collection of mature oaks trees including the historic Old Glory Oak.

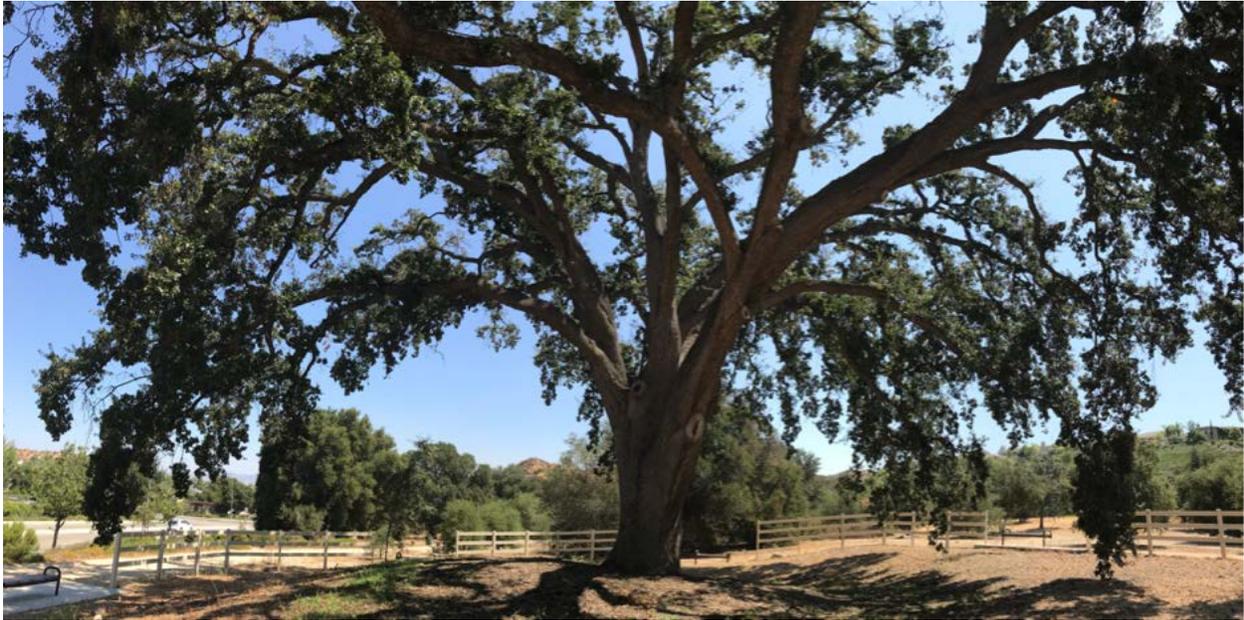
The Old Glory Oak is showing new growth since being transplanted in 2004, and appears in fair condition. This tree should be relatively tolerant of construction activity outside of dripline, which is surrounded by an existing split rail fence. Add tree protection fencing signage to the split rail fence designating the area a protected zone. Additionally, a line of temporary construction fencing should be installed adjacent to the new construction. Monitor the hydration of the tree and perform regular deep soaking throughout construction.

Photo 1 - The Old Glory Oak in its current condition. This tree has pushed out extensive new growth during its establishment over the past 10 years. The existing fence surrounding the dripline of this tree will be utilized as protective fencing throughout the course of construction.

The Old Glory Oak is currently protected at the dripline by an existing split rail fence. **This fence will serve as the primary protective fencing throughout the course of construction, with signage designating the area a protected zone.**

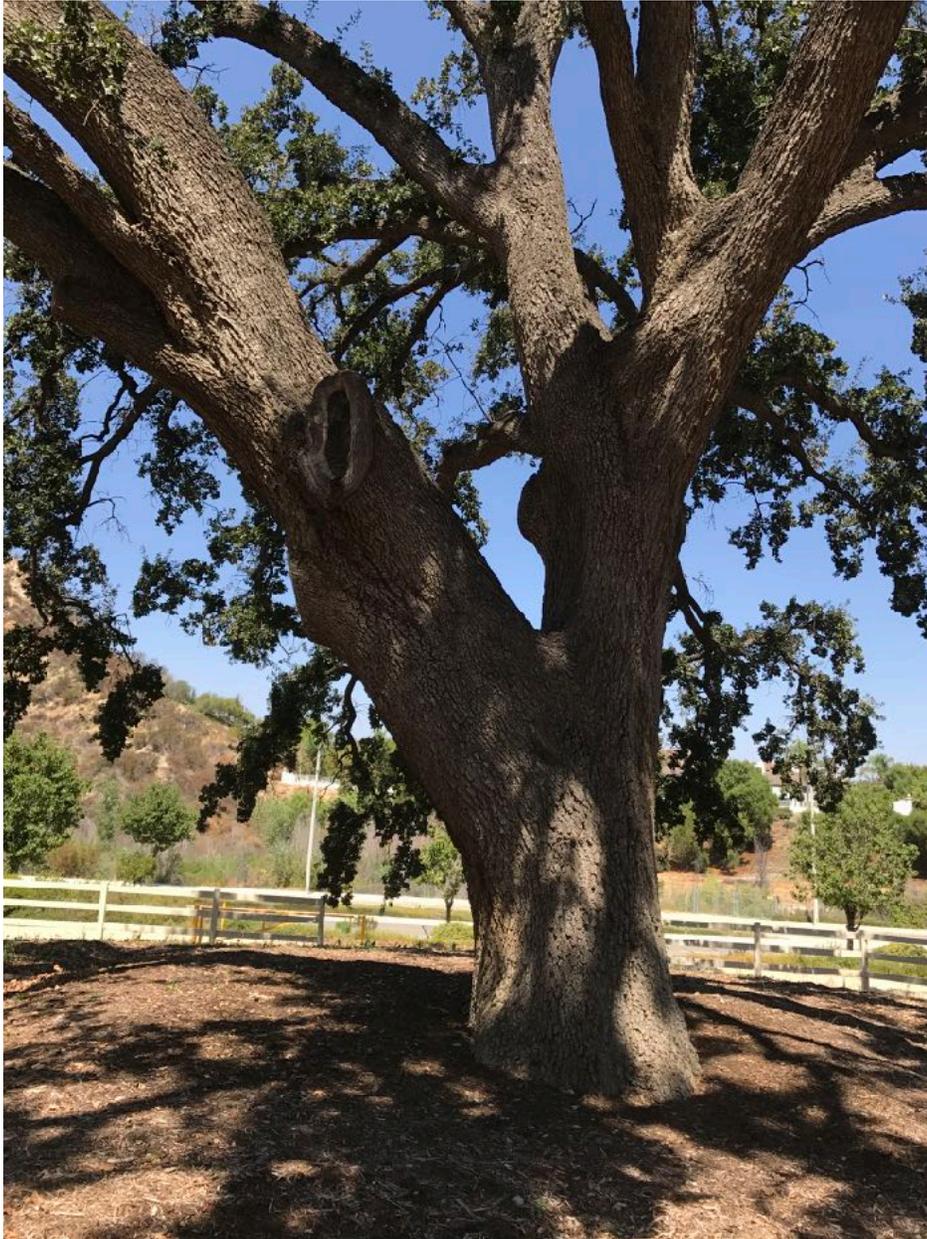
Photo 2 - A view of the base of The Old Glory Oak, showing appropriate taper and root flare.

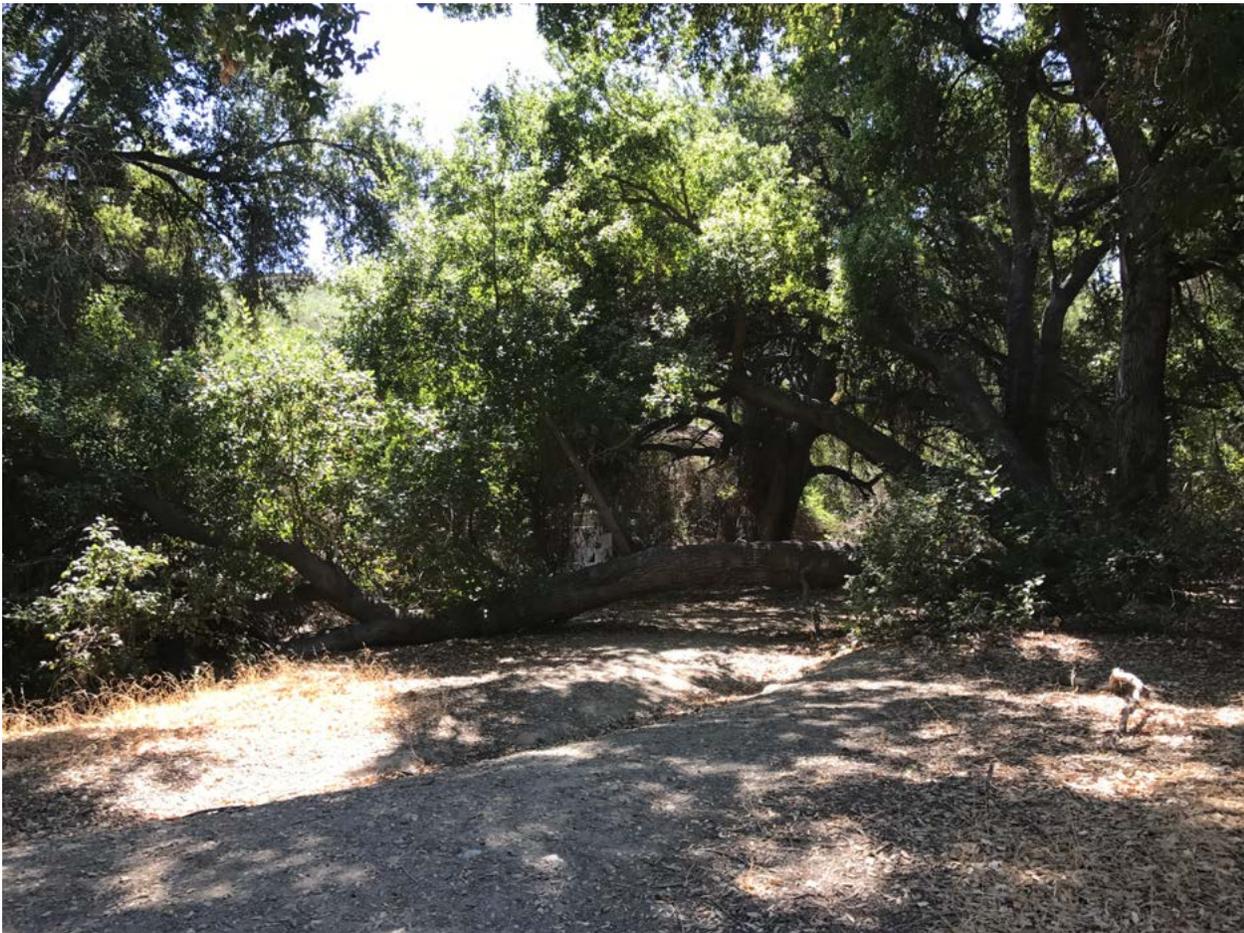
Photo 3 - A view of Area 2, where trenching may occur. There is a collection of oaks in this area which have recently had a greater water availability due to a water collection pipe installed approximately 18 years ago.

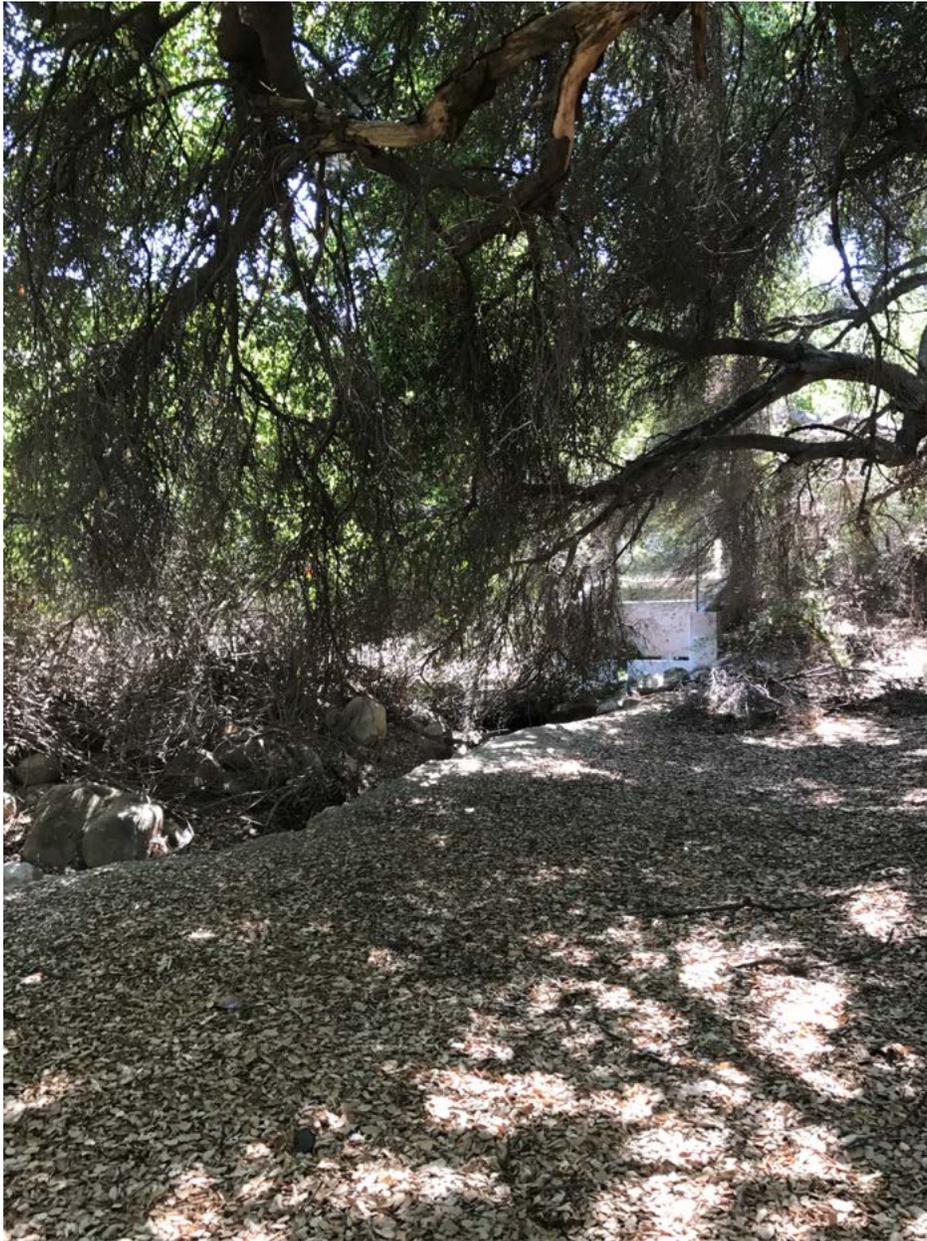
Photo 4 - The water collection runs through this small stream and allows for a continual supply of water to the roots of this oak area.

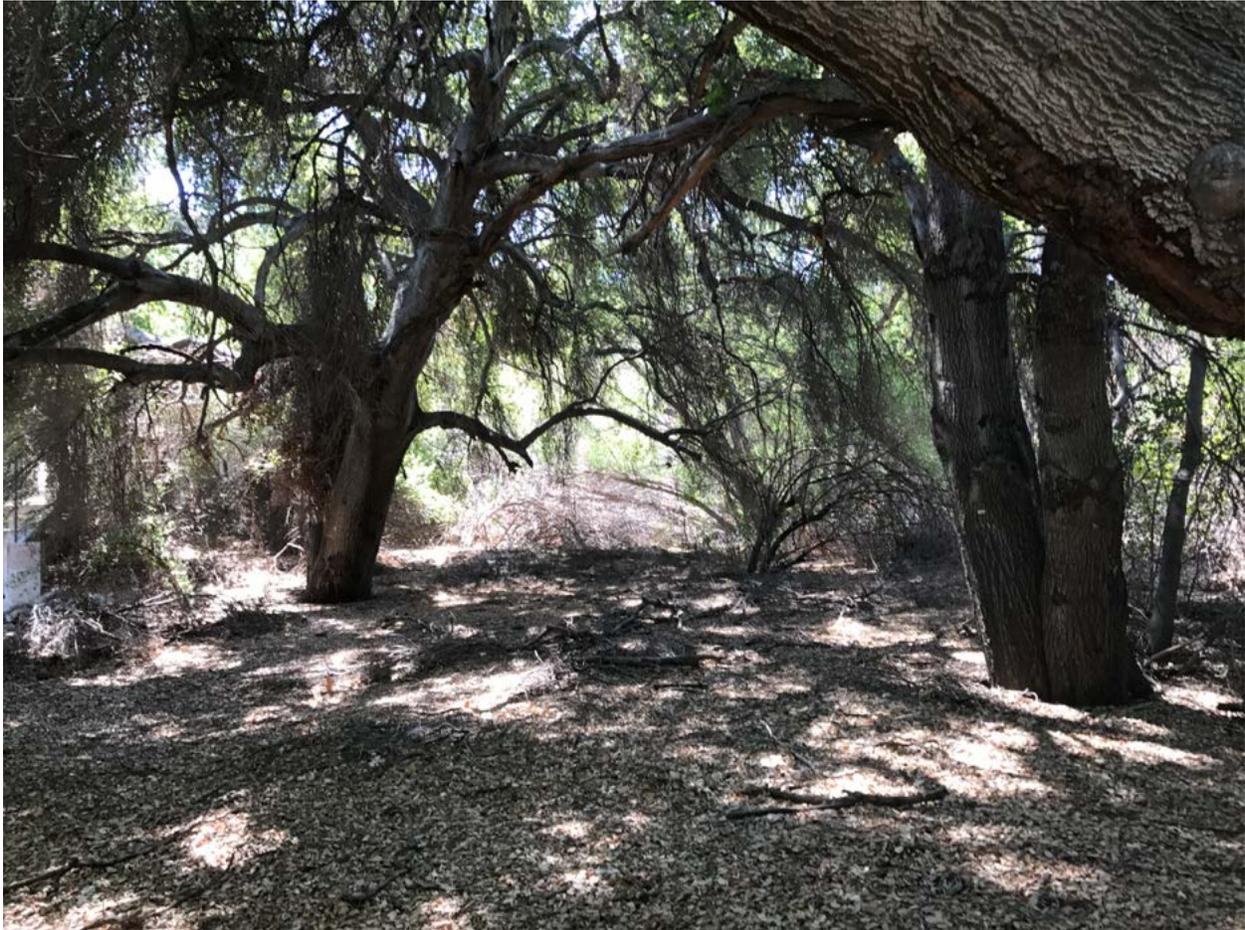
Photo 5 - Note there is extensive deadwood in many of these trees. Prior to the commencement of any work, these trees should have deadwood pruning performed. This is not a safe working environment and there is great potential for dead stems and branches to drop and potentially cause injury.

- 1) **Have the Project Arborist assess the trees in Area 2 for structurally deficient or dead branches. Prune out identified deadwood and deficient branches** on all trees to minimize branch failure onto any workers before work begins. Perform mitigation pruning (such as end weight reduction) to reduce risk on branches that have potential for failure within the next 12 months.

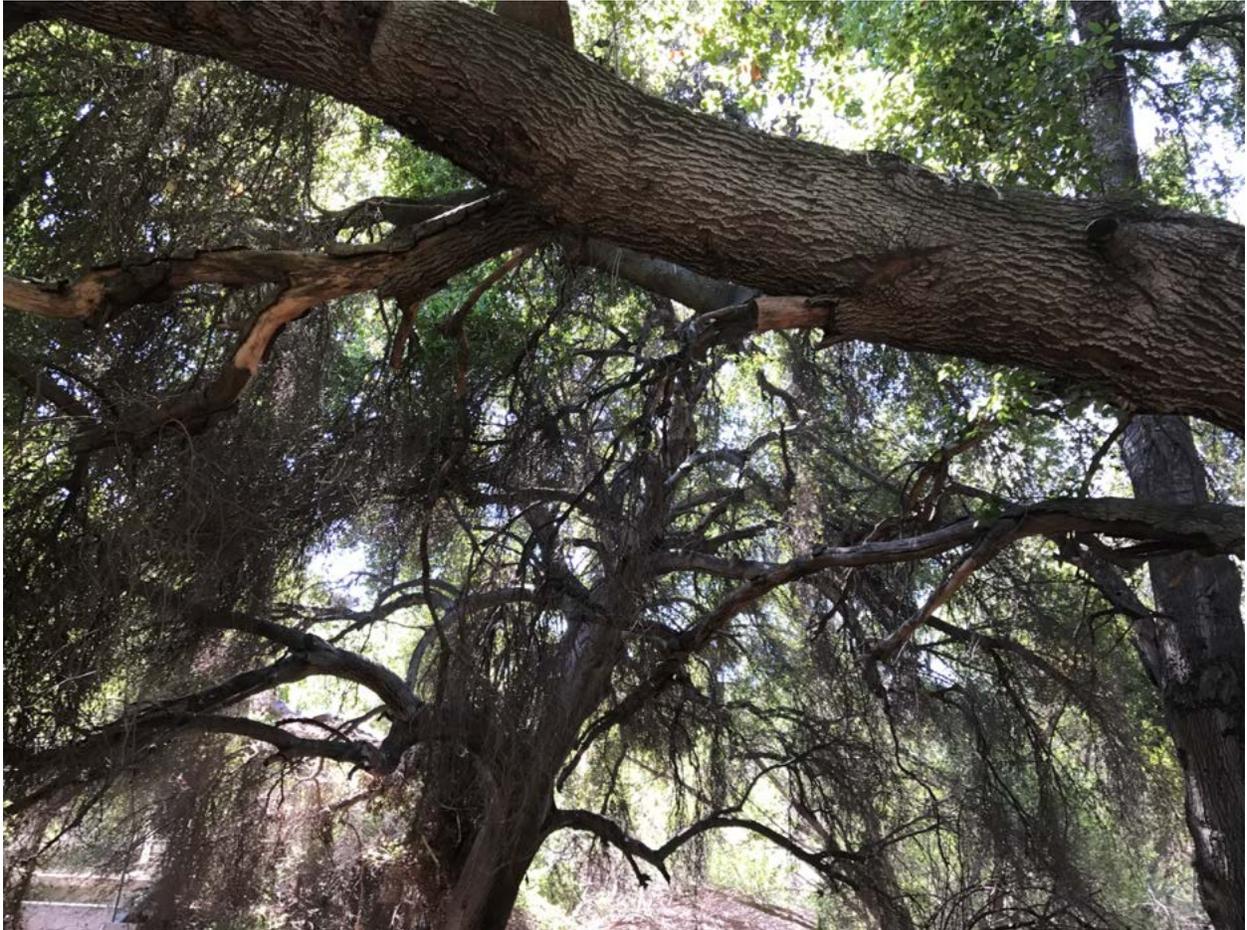
Photo 6 - Note close up of extensive deadwood in canopies.

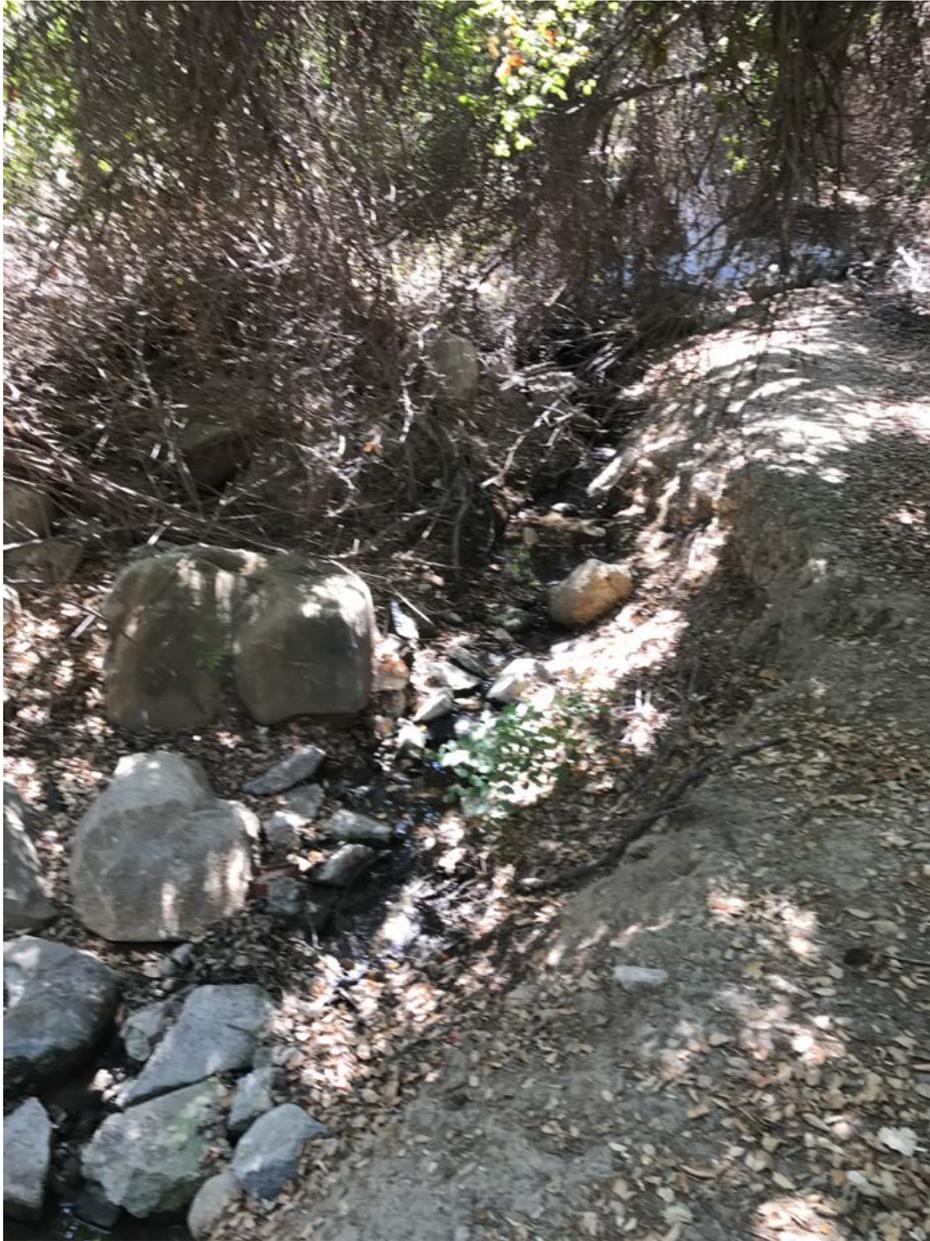
Photo 7 - Current conditions of stream adjacent to collection of oaks.

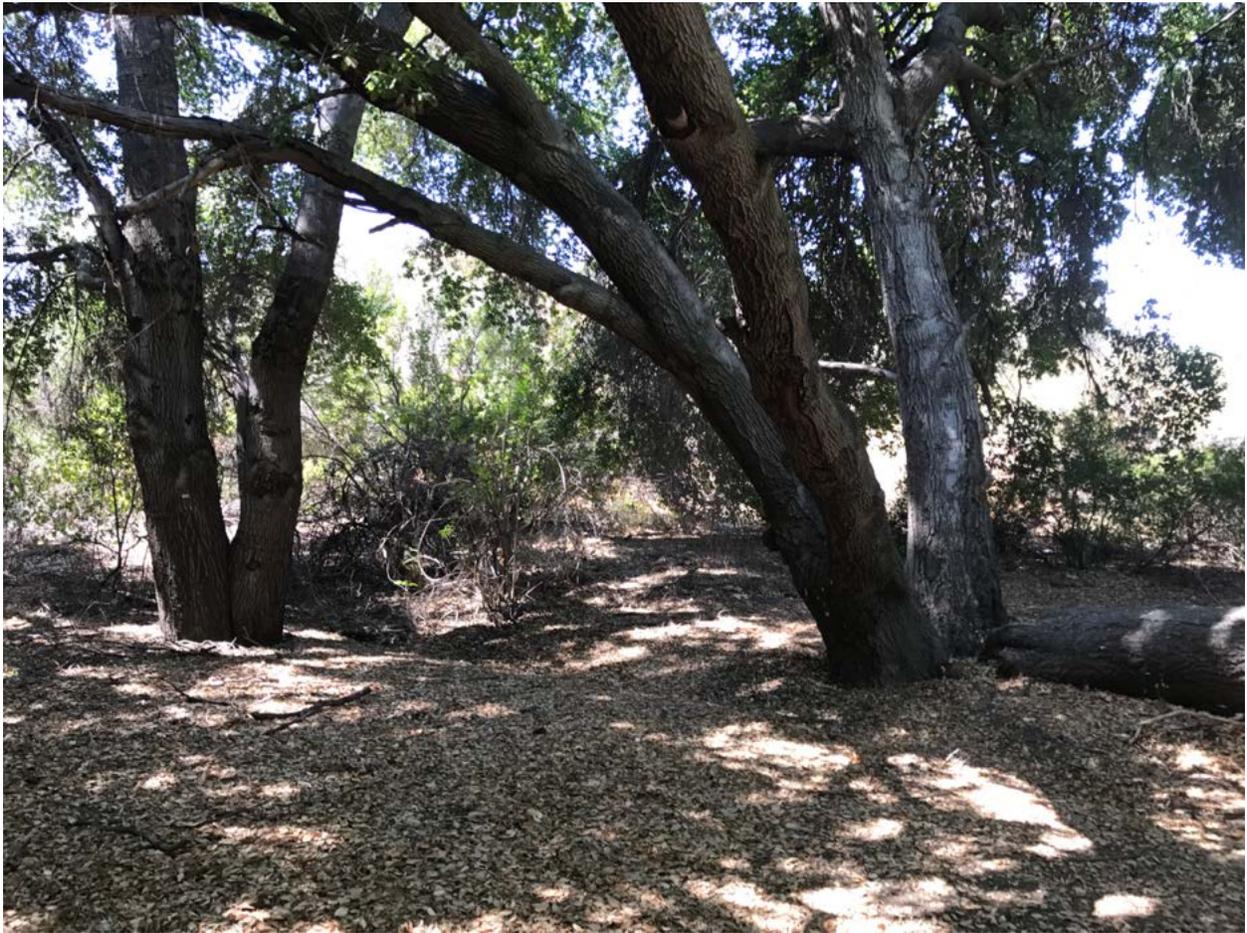
Photo 8 - This photo shows some of the oaks adjacent to the small stream.

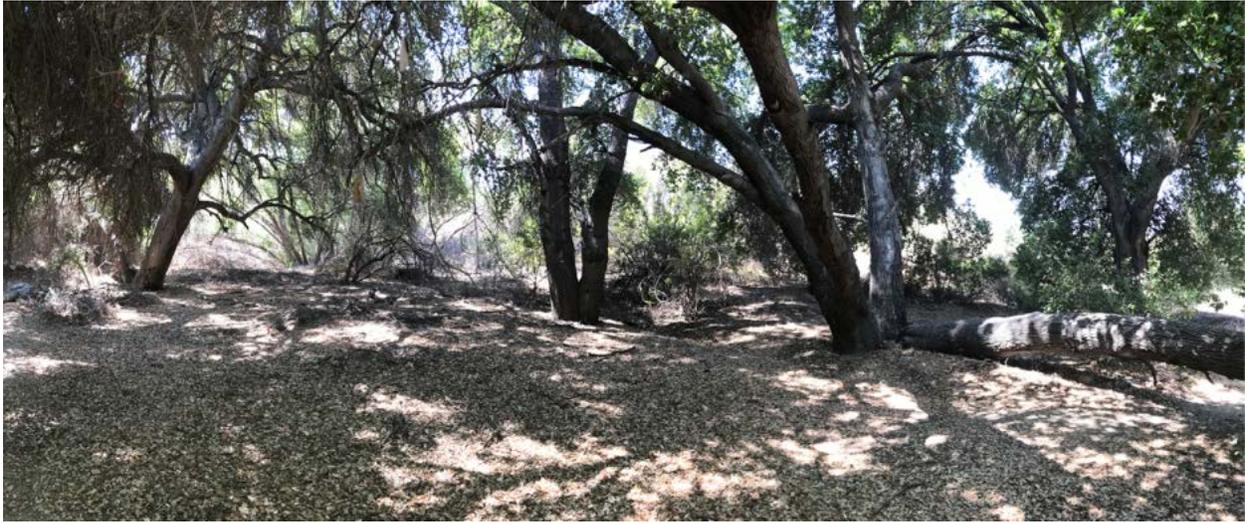
Photo 9 - Panoramic view of the collection of oaks in this area.

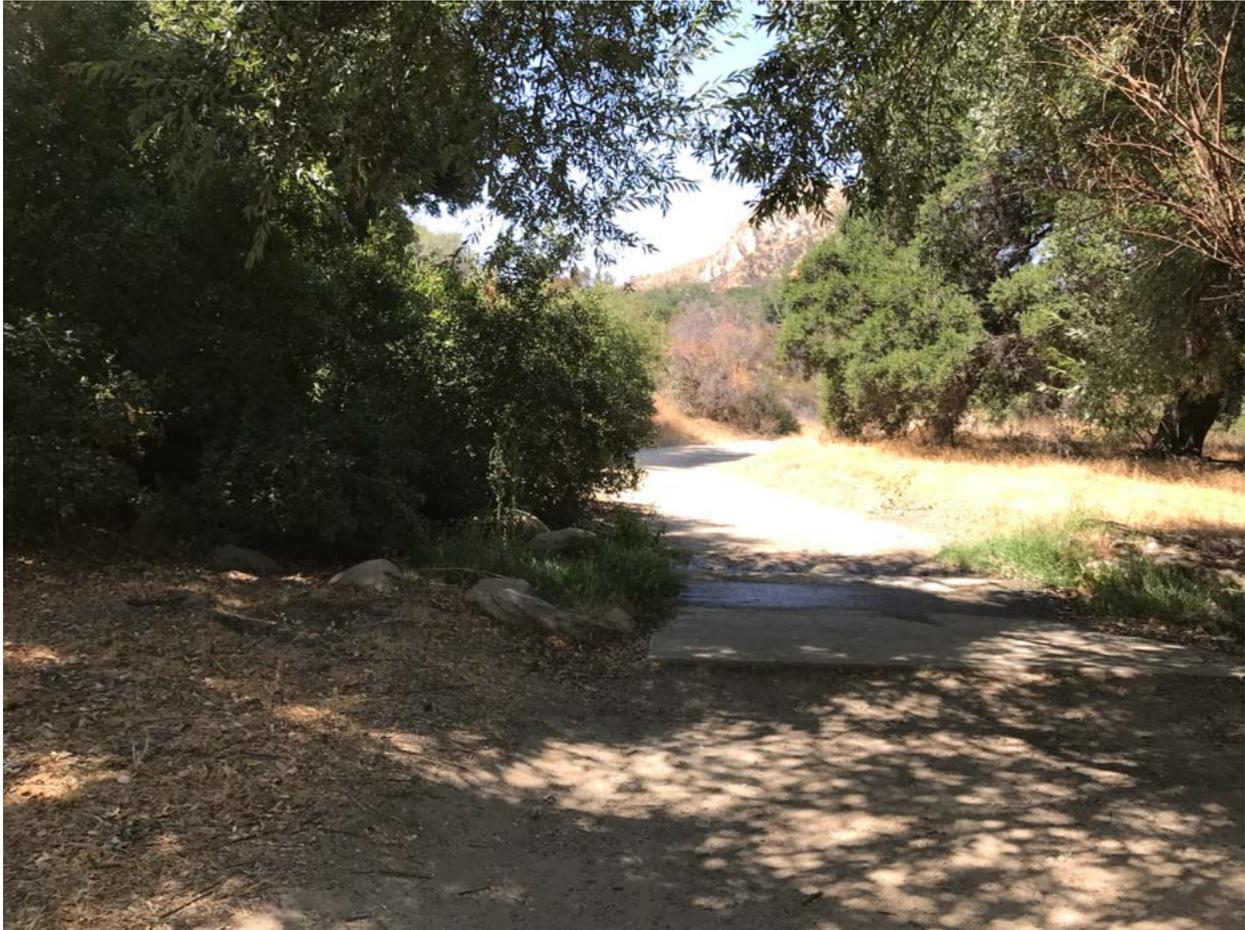
Photo 10 - The proposed piping would travel under this pathway and to the right, into another collection of oak trees.

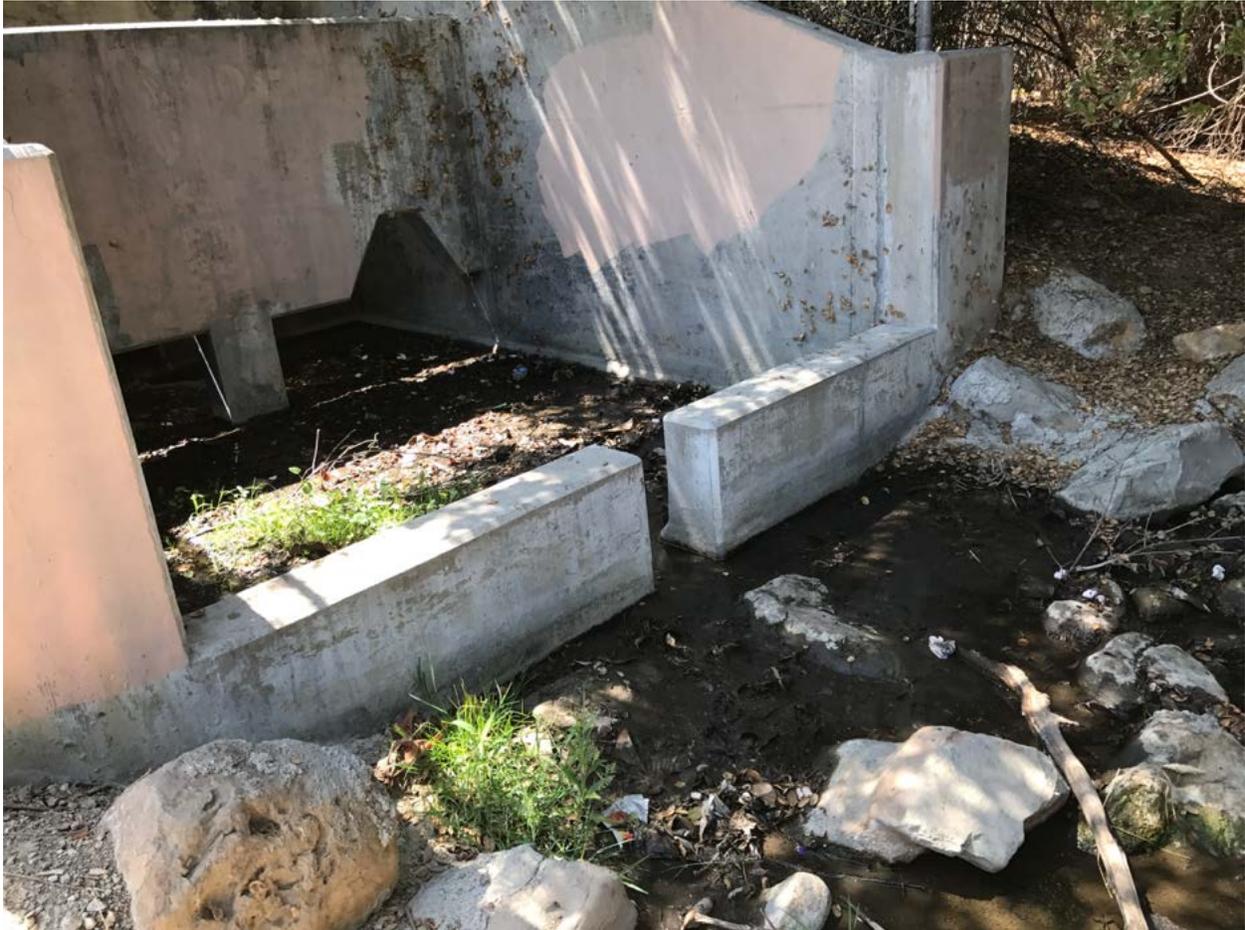
Photo 11 - This shows the water culvert and where the excess water from the hillside finally is captured. It empties out into the small stream that runs past the collection of oak trees in Area 2.

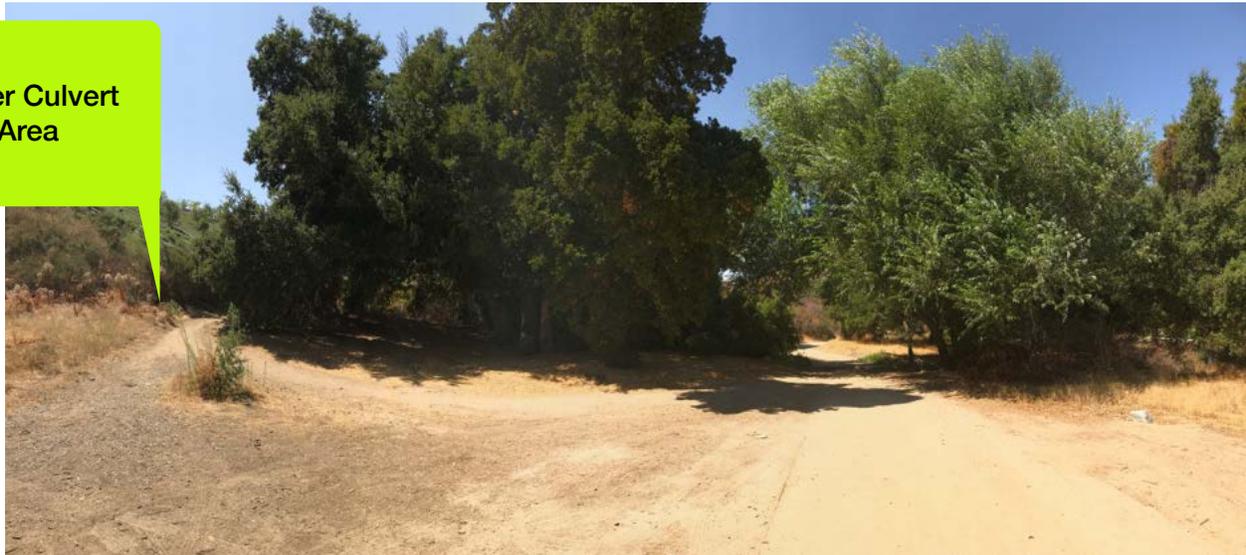
Water Culvert
Area

Photo 12 - Collection of oaks on either side of the path. The piping would connect on the left and run through the grove to the right.

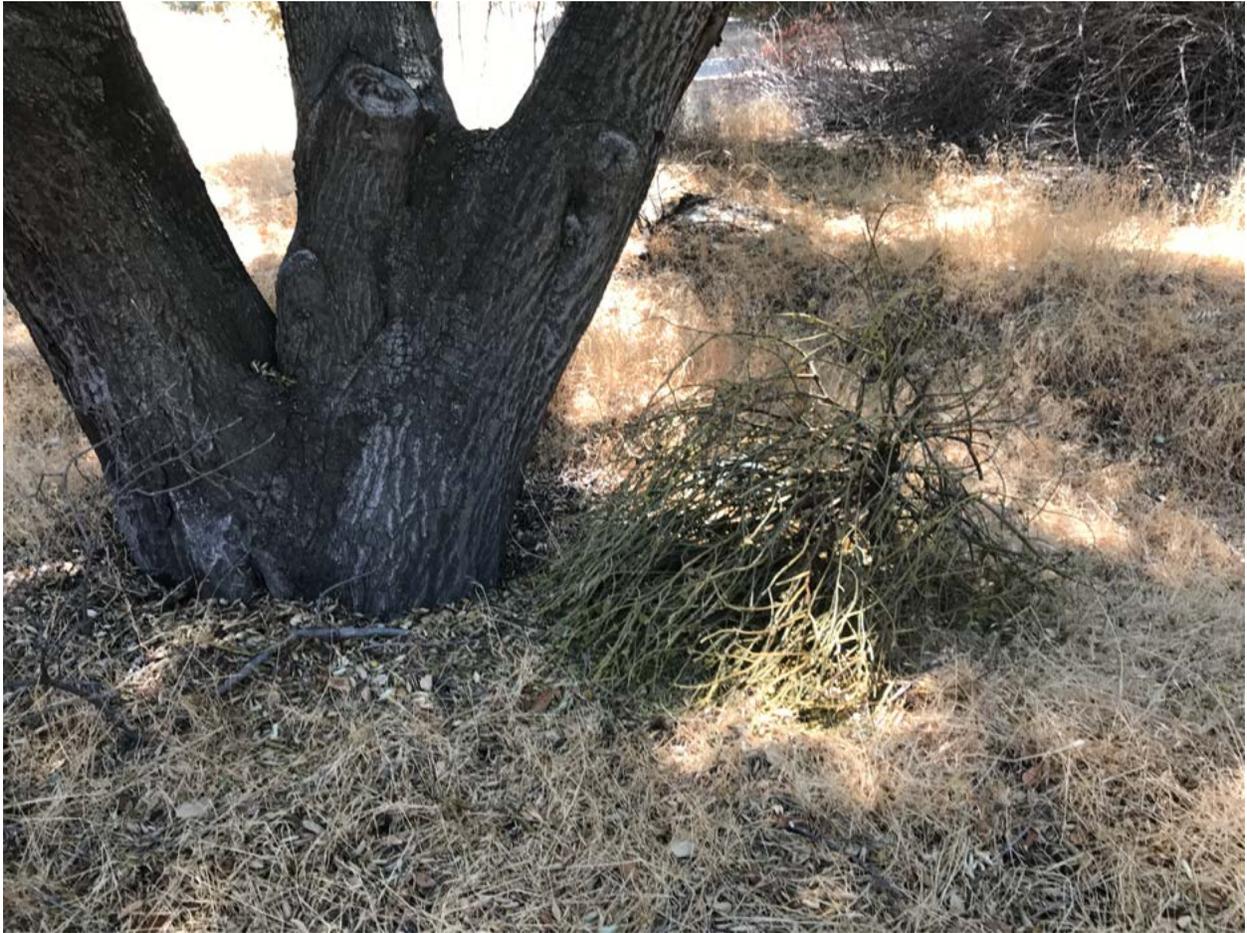
Photo 13 - Mistletoe was noted in the canopies of several oaks. This should also be pruned out.

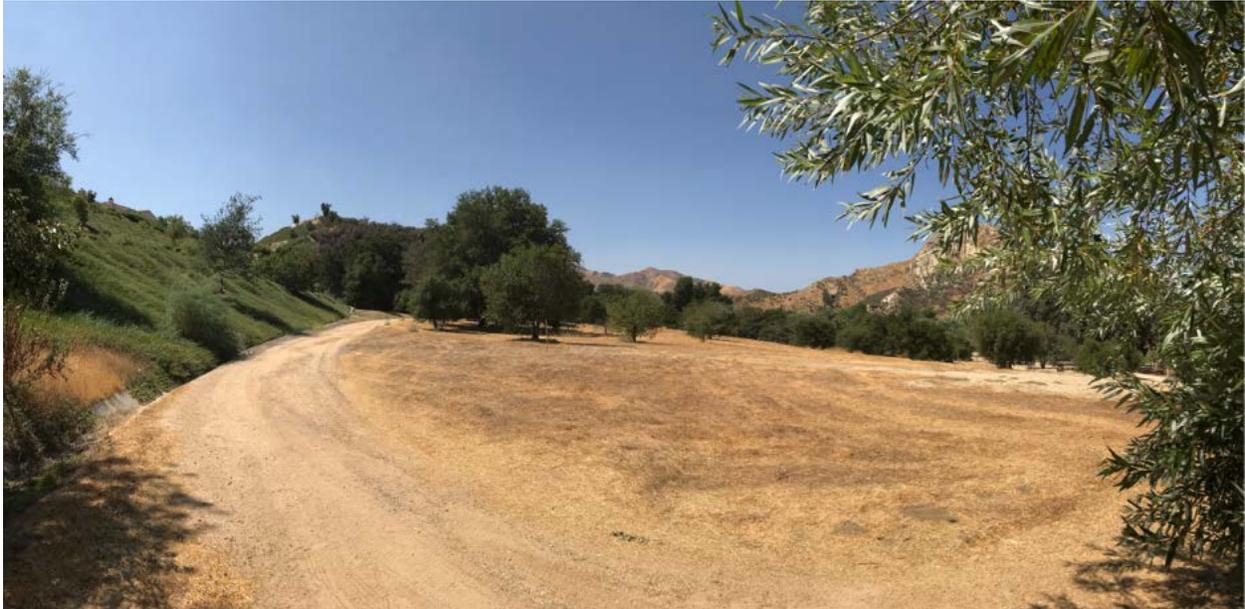
Photo 14 - the upper hillside (left) has extensive ground cover that is watered causing runoff to occur weekly into the V-ditch below.

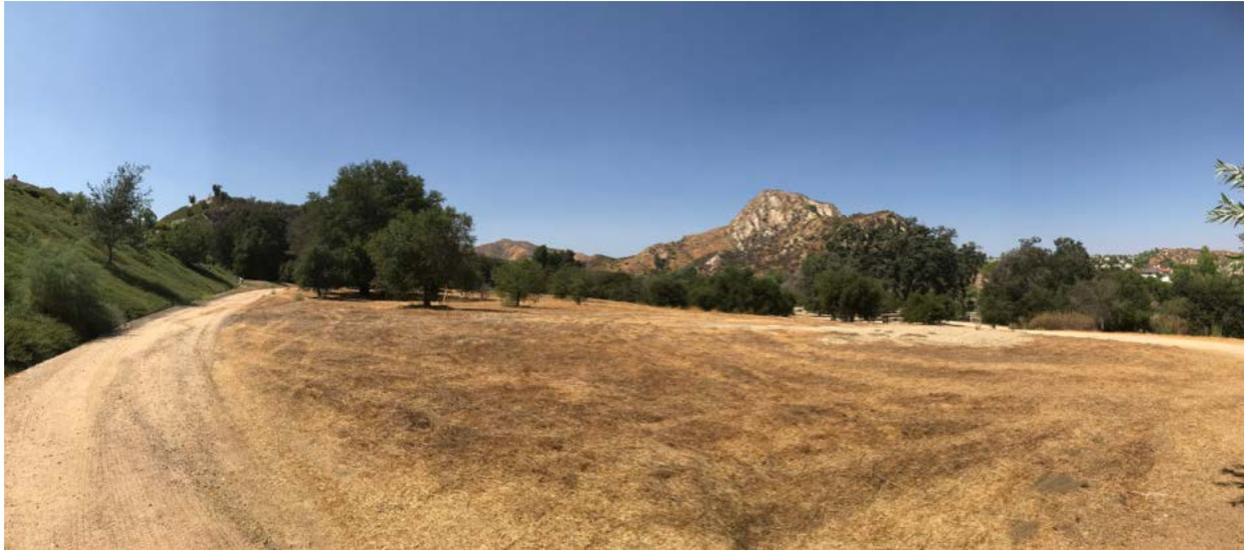
Photo 15 - This area is open and can be utilized for any replacement trees or other dedicated activity.

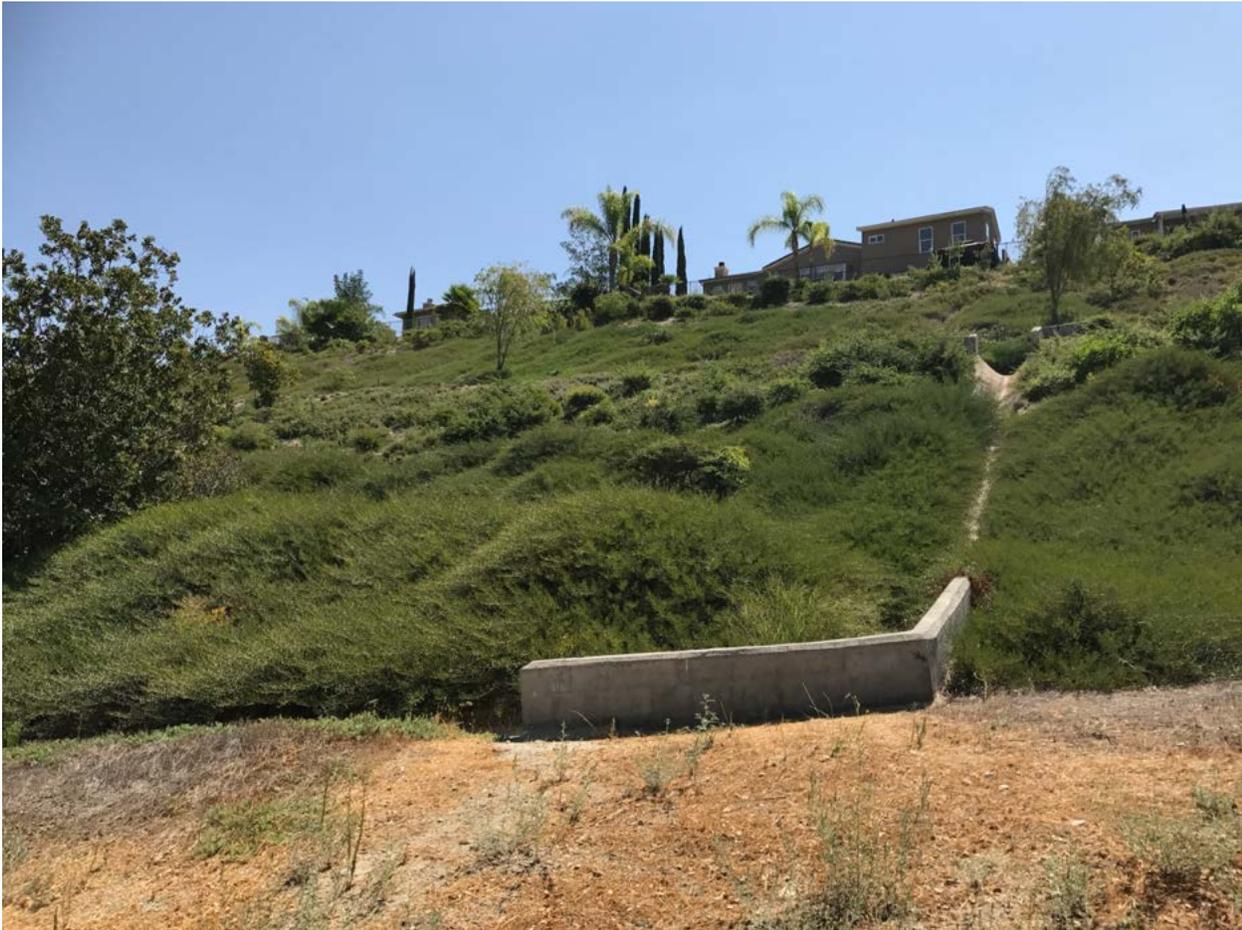
Photo 16 - Note the extensive ground cover and V-ditches to capture water runoff. This area is open and can be utilized for any replacement trees or other dedicated activity.

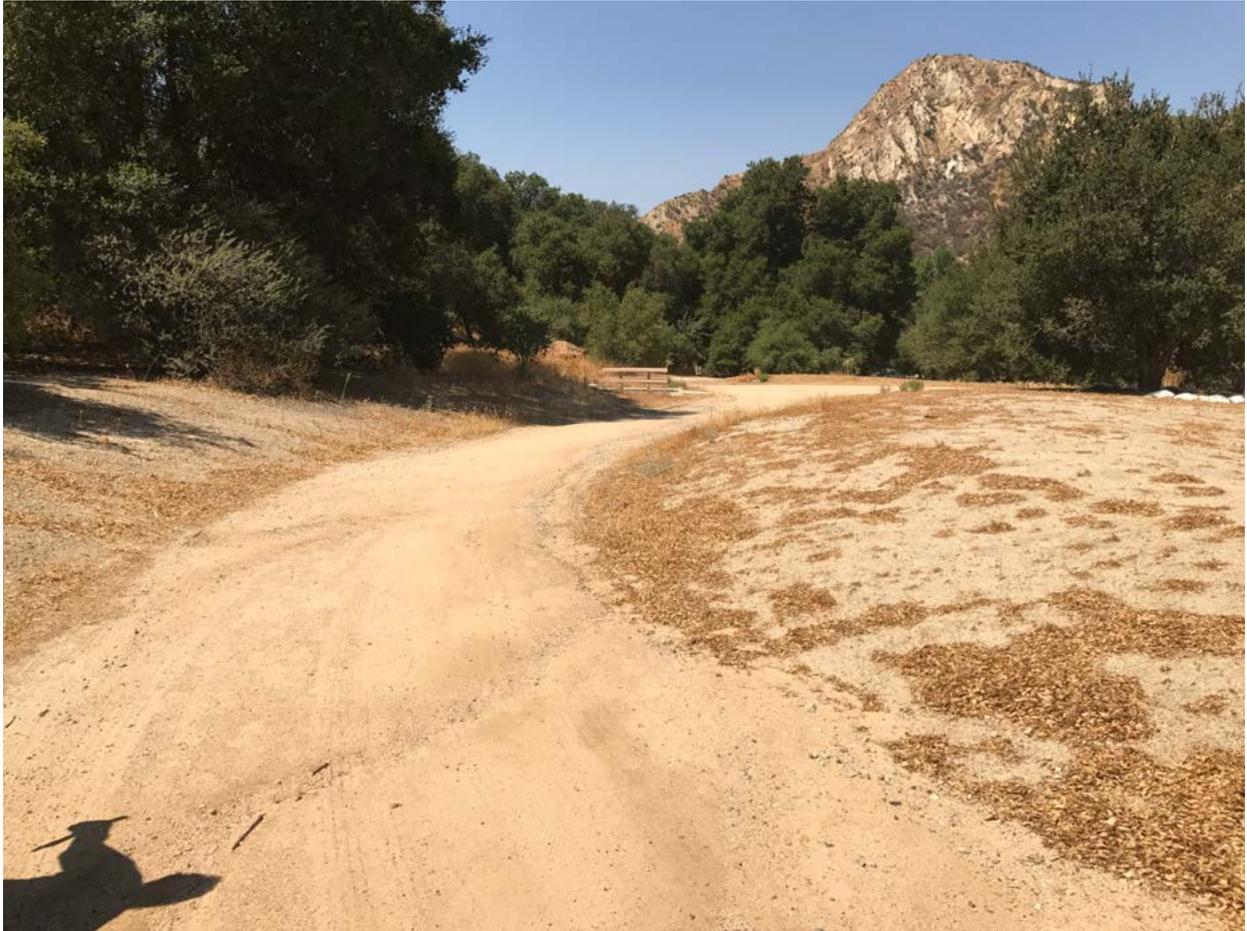
Photo 17 - Note the runoff that is occurring throughout this park when there is excess water or rain.
