TREE REPORT

Pico Canyon Park

Los Angeles County is preparing to install a new stormwater infiltration system in Pico Canyon Park. This park includes a collection of mature oaks trees including the historic Old Glory Oak.

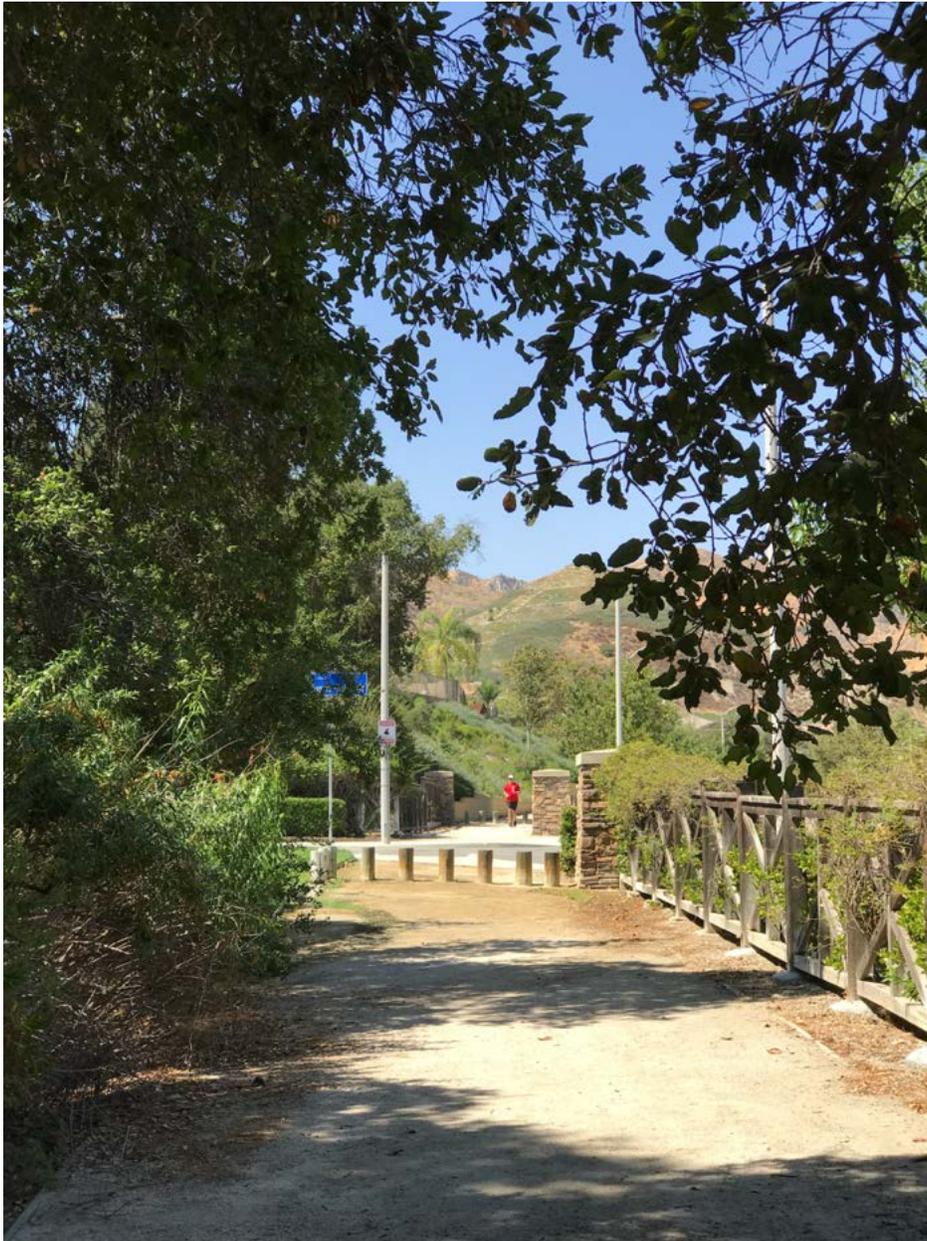
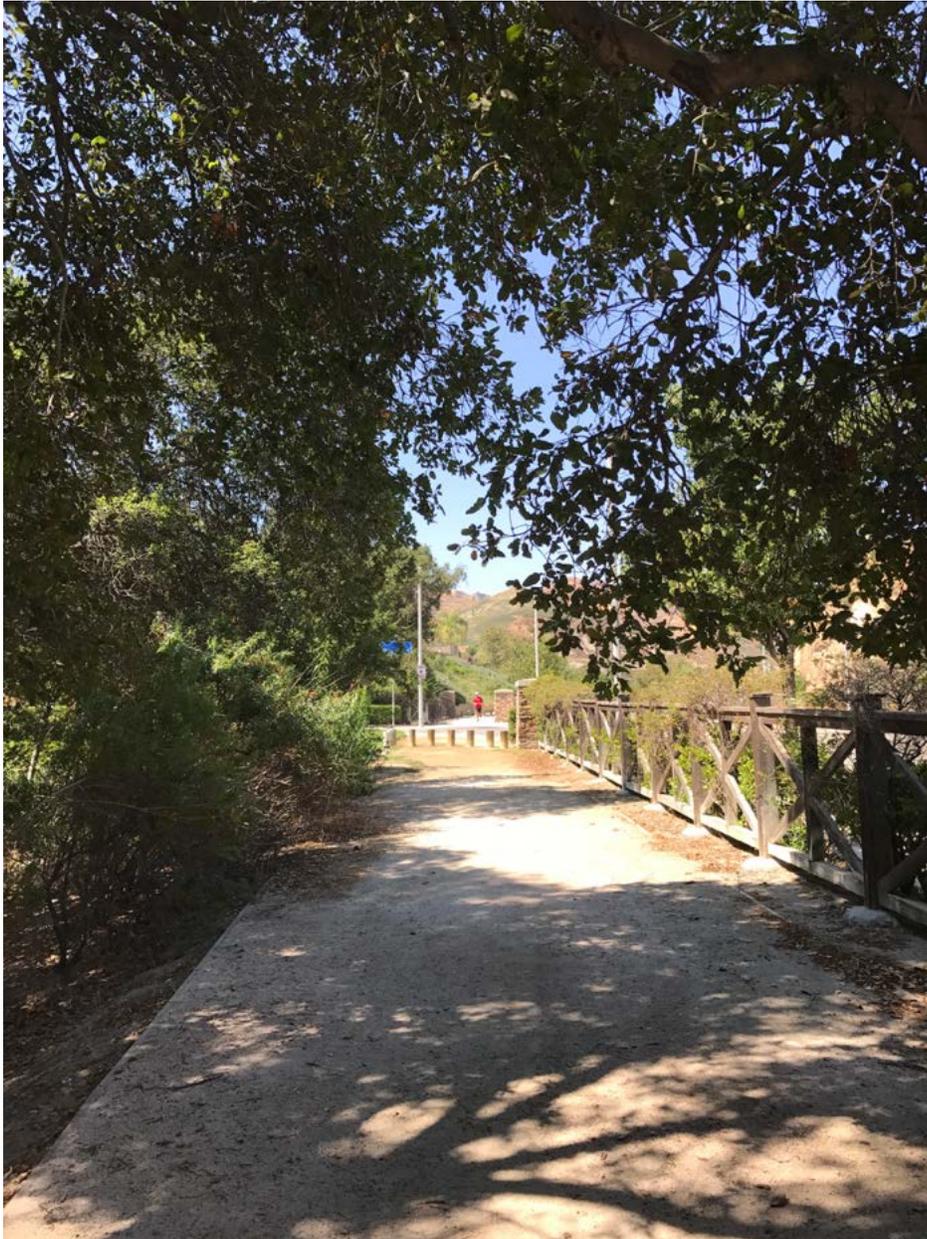
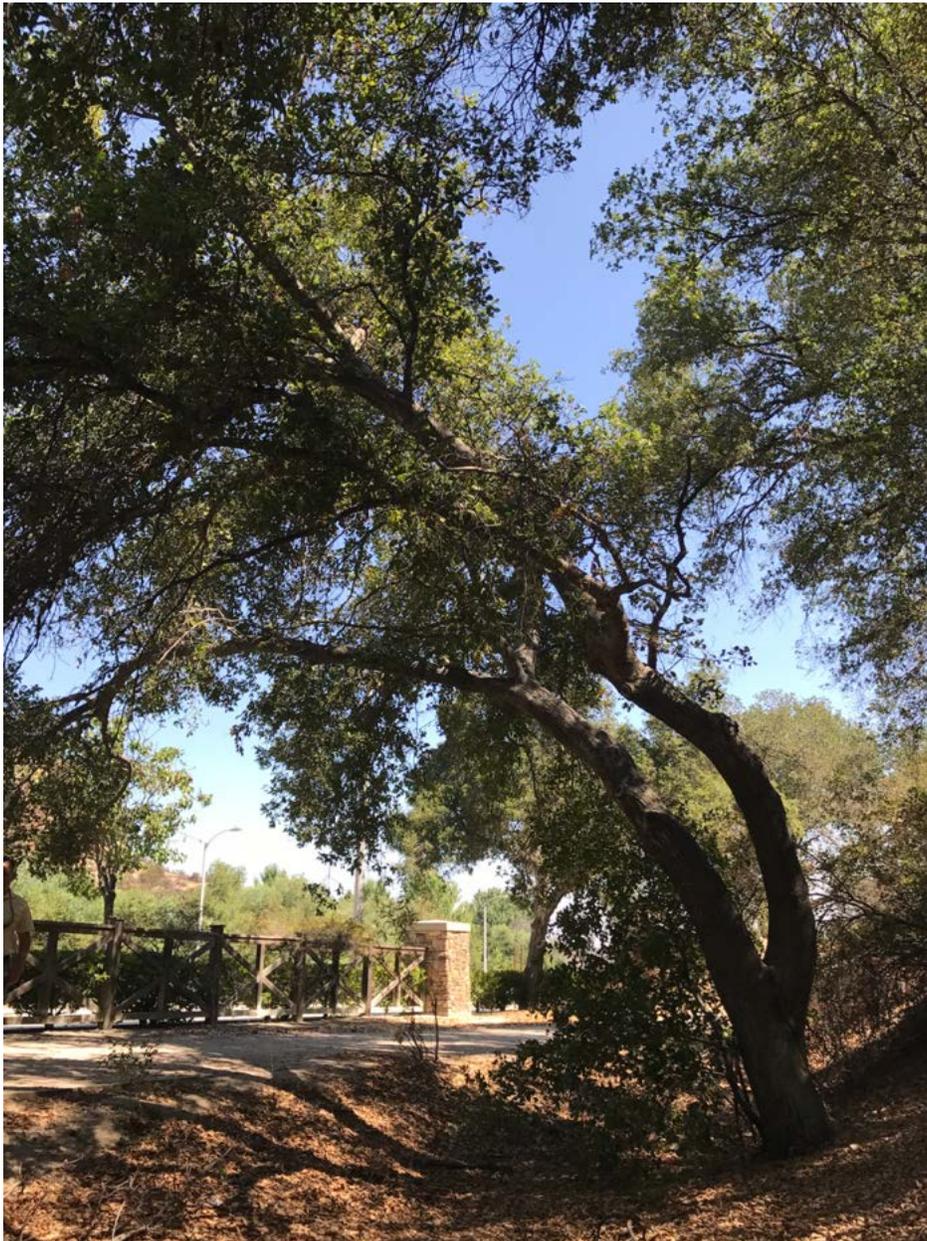
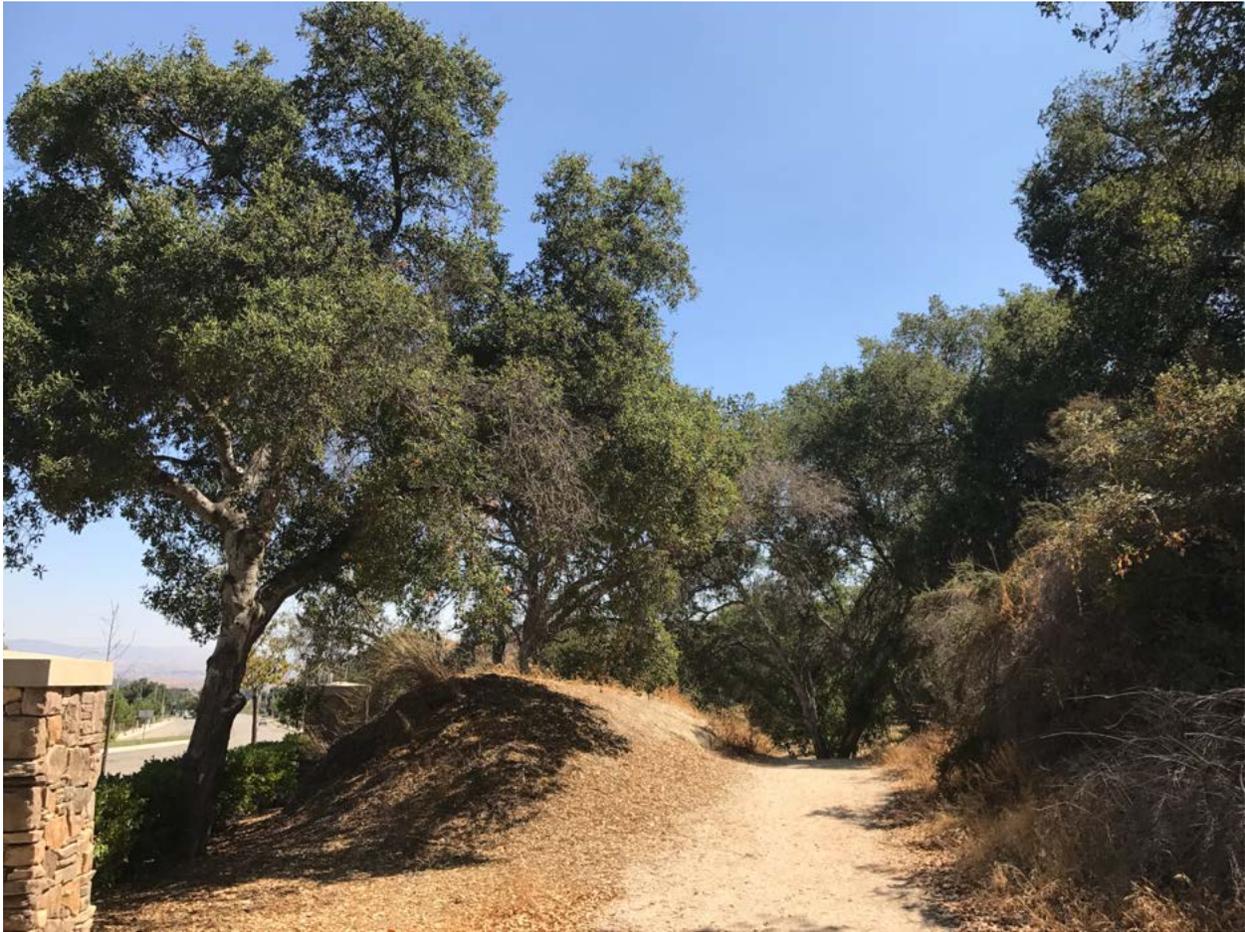
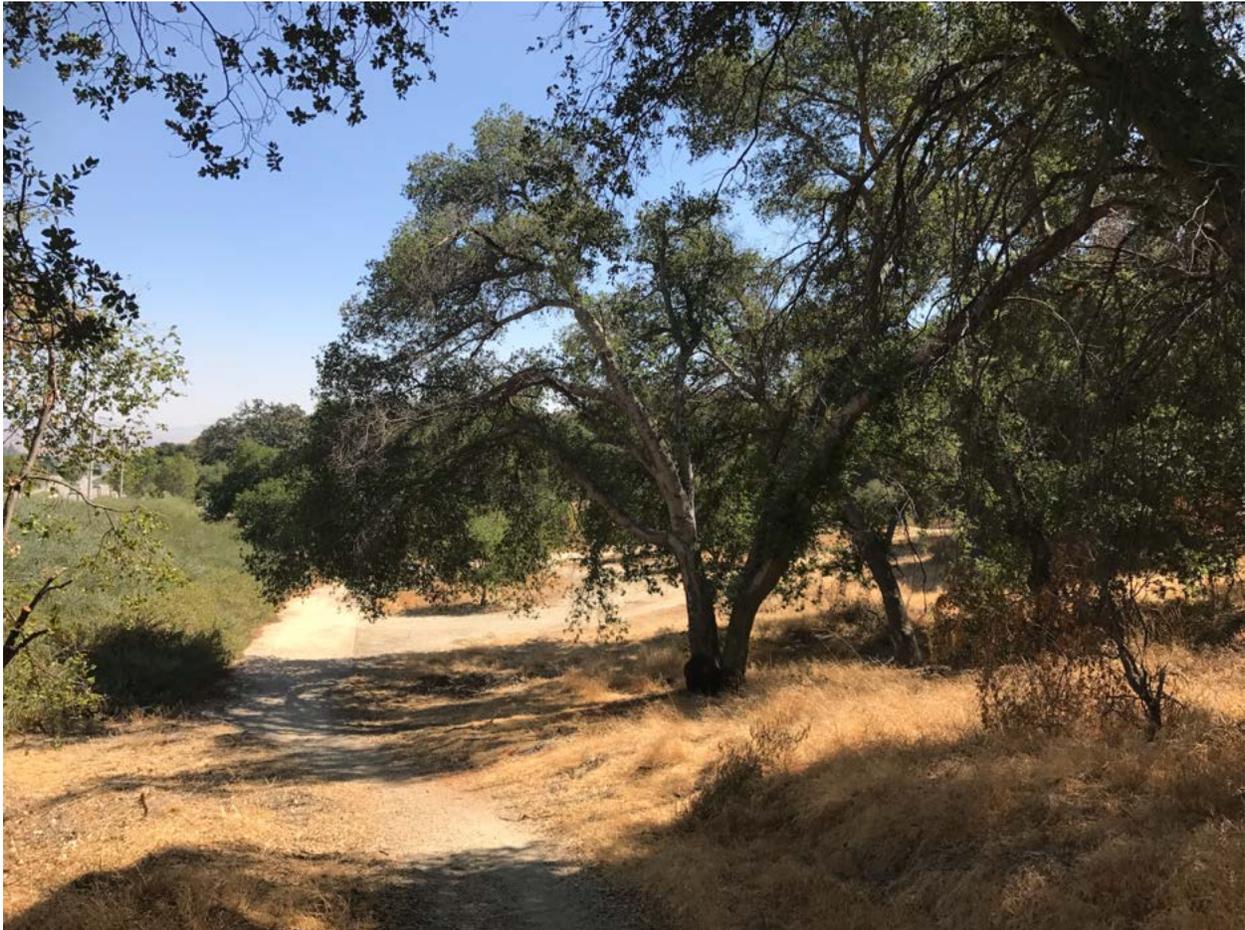
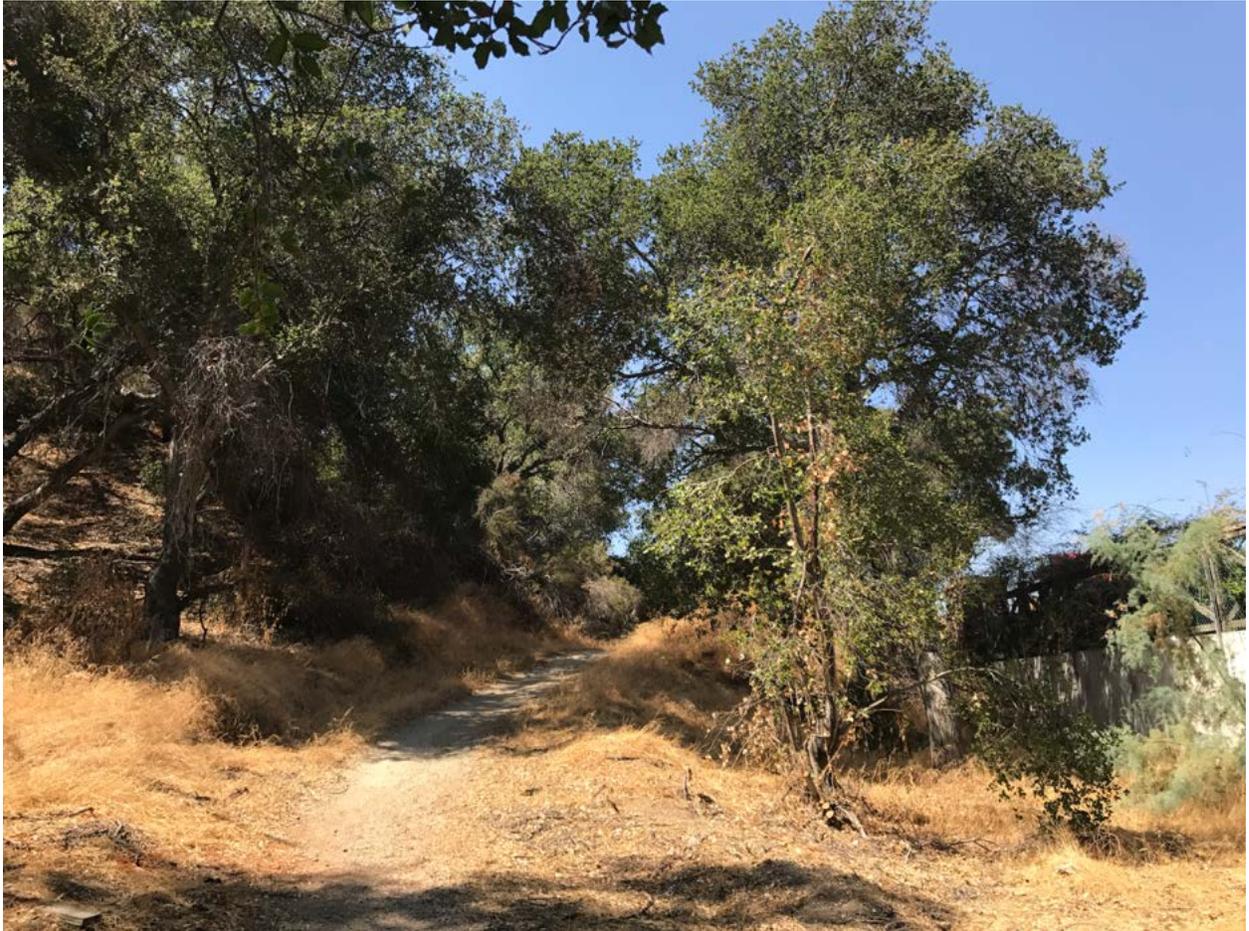
Photo 18 - This trail was identified in earlier designs as a potential location to begin the pipe line, however it is no longer being impacted.
