TREE REPORT

Pico Canyon Park

Los Angeles County is preparing to install a new stormwater infiltration system in Pico Canyon Park. This park includes a collection of mature oaks trees including the historic Old Glory Oak.

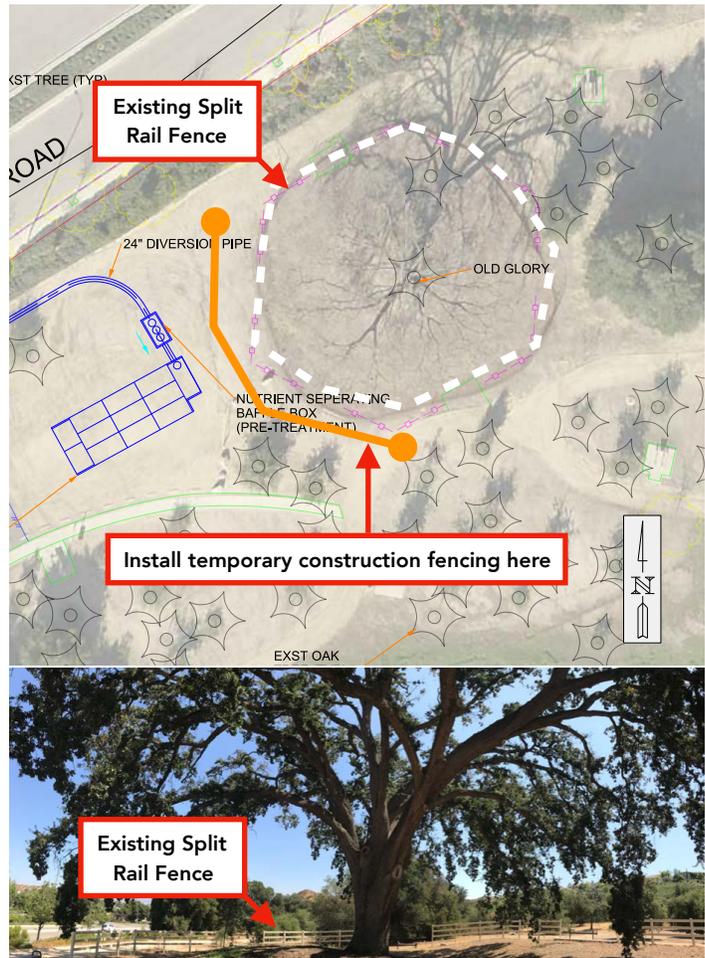
The Old Glory Oak is currently protected at the dripline by an existing split rail fence. **This fence will serve as the primary protective fencing throughout the course of construction, with signage designating the area a protected zone.**

Additionally, a line of temporary construction fencing should be installed adjacent to the new construction. This fencing should be set back 5 feet from the split rail fence perimeter and installed in the location indicated in the diagram on the right.

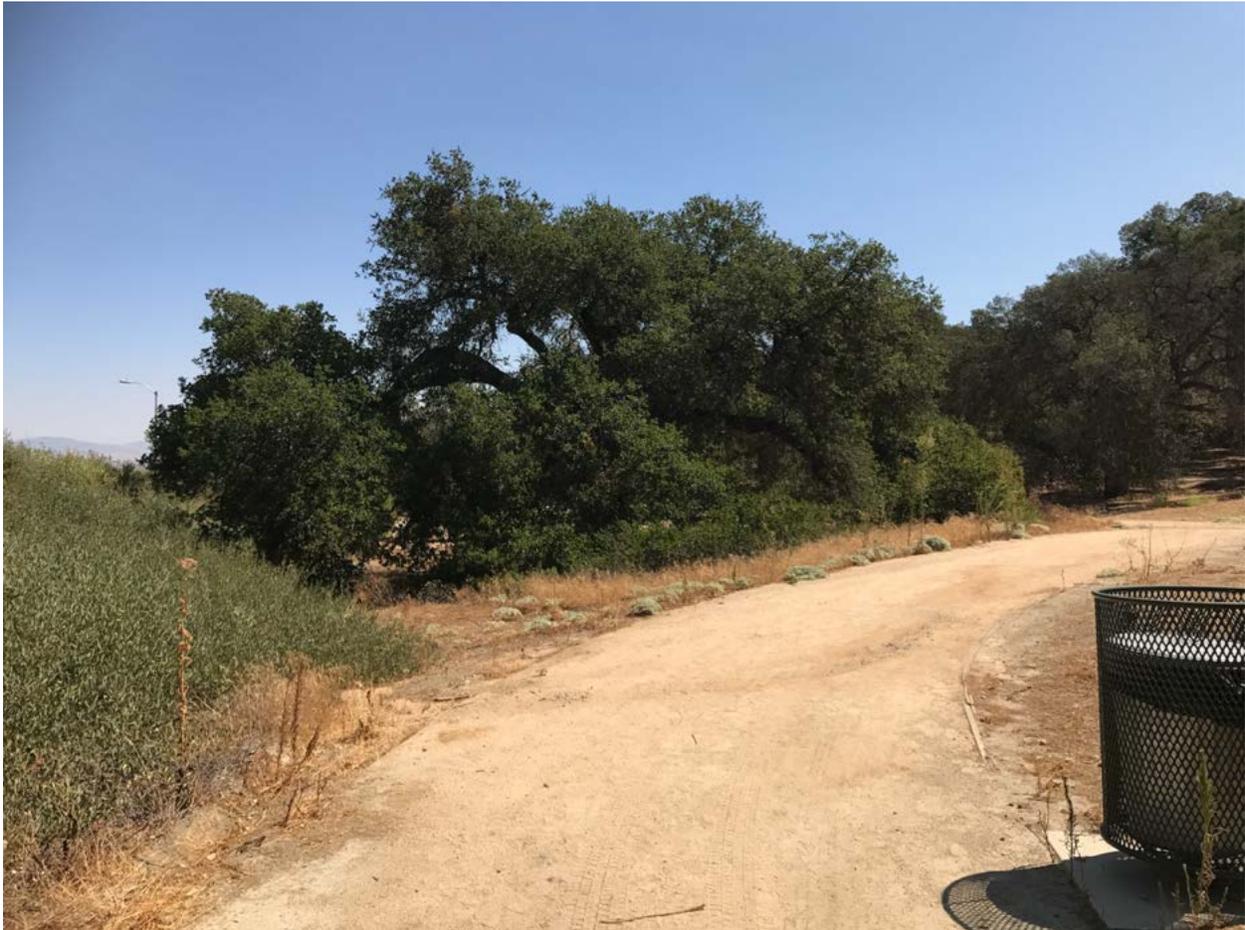
Photo 24 - This trail was identified in earlier designs as a potential location to begin the pipe line, however it is no longer being impacted.
