# SAN GABRIEL VALLEY REGIONAL CONFIRMATION OF INFILTRATION RATES

June 22, 2022

East San Gabriel Valley Watershed  
Management Group

**Project Number:** 184031383

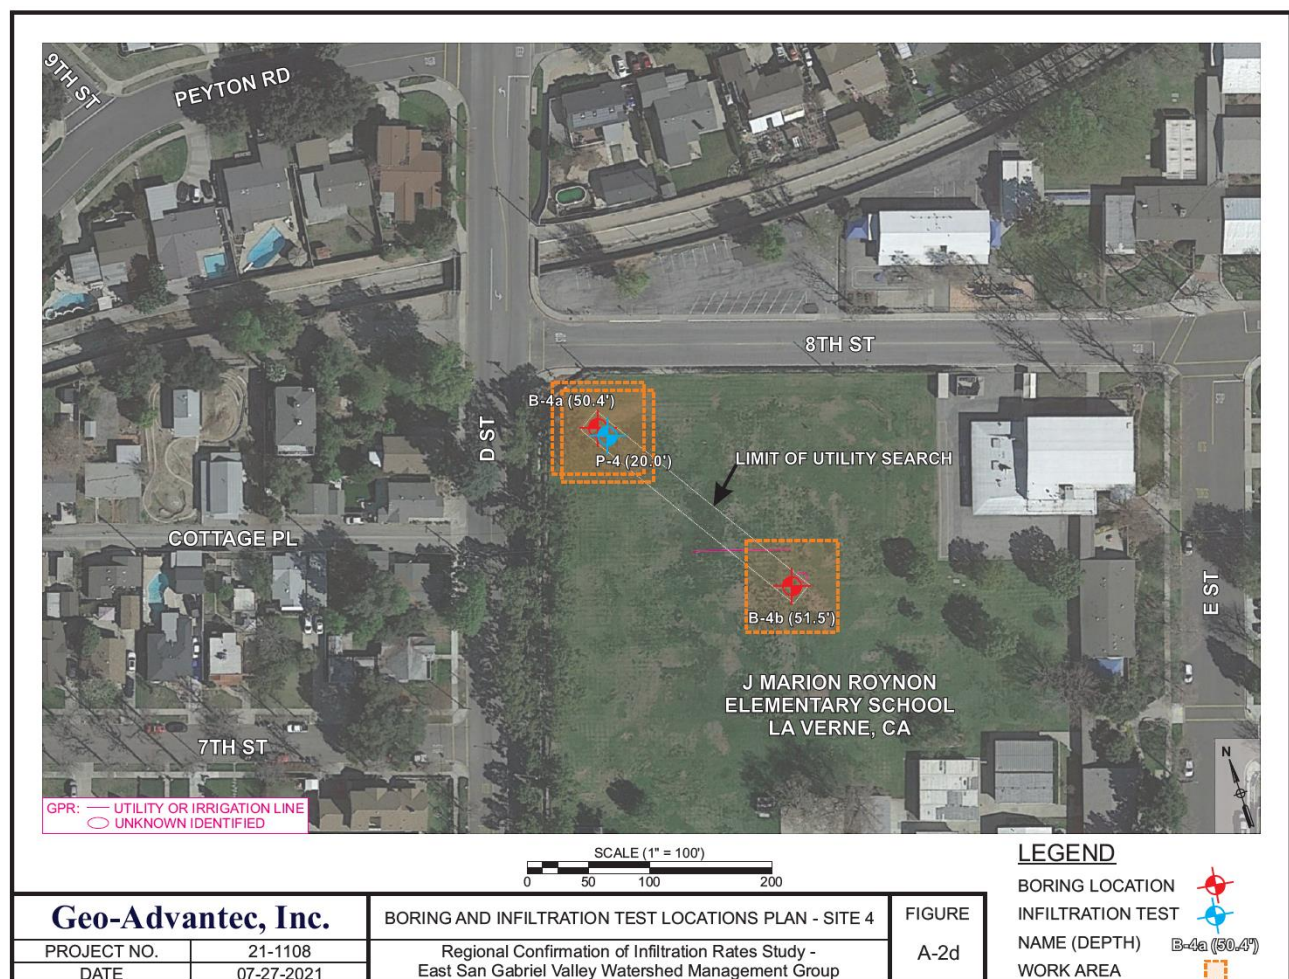
**Figure 6. J Marion Roynon Elementary School, La Verne Boring and Infiltration Locations**

Infiltration testing is being performed at the boring and infiltration locations shown in **Table 7** and on **Figure 6**.

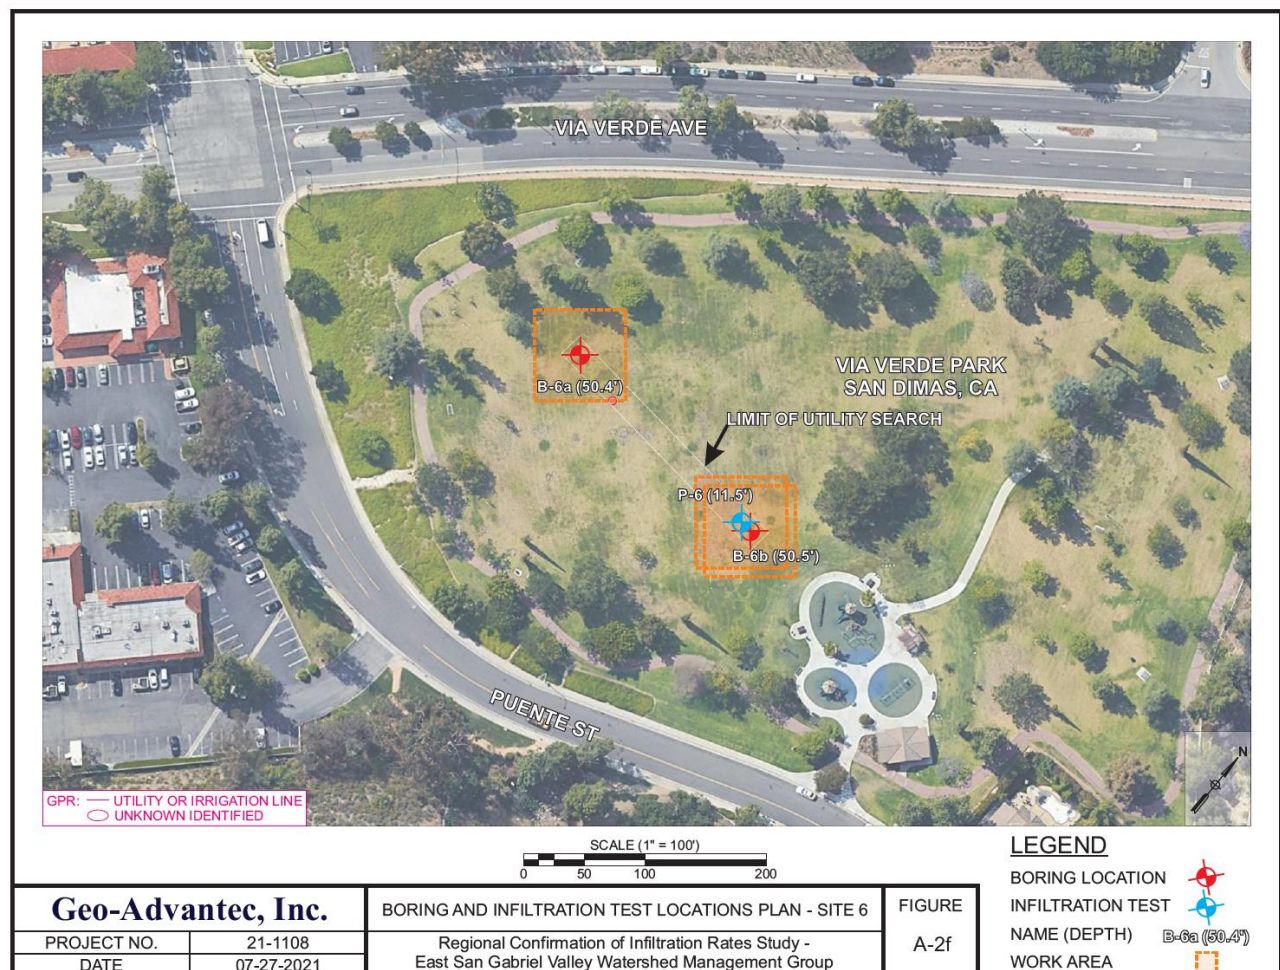
**Figure 10. Via Verde Park, San Dimas Boring and Infiltration Locations**

Infiltration testing is being performed at the boring and infiltration locations shown in **Table 11** and on **Figure 10**.

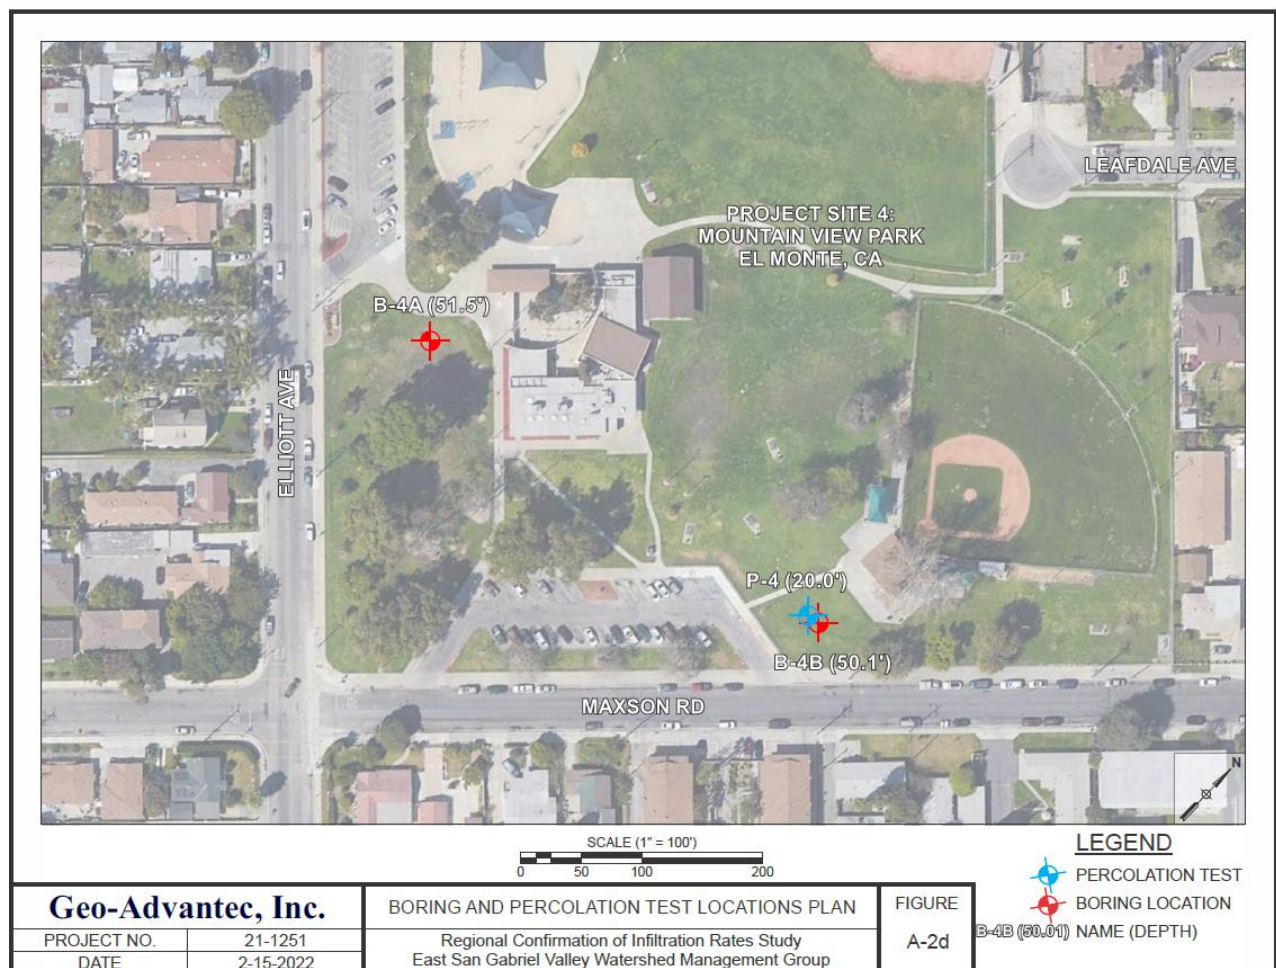
**Figure 18. Mountain View Park, El Monte Boring and Infiltration Locations**

Potential boring and infiltration testing locations are shown in **Table 19** and on **Figure 18**.

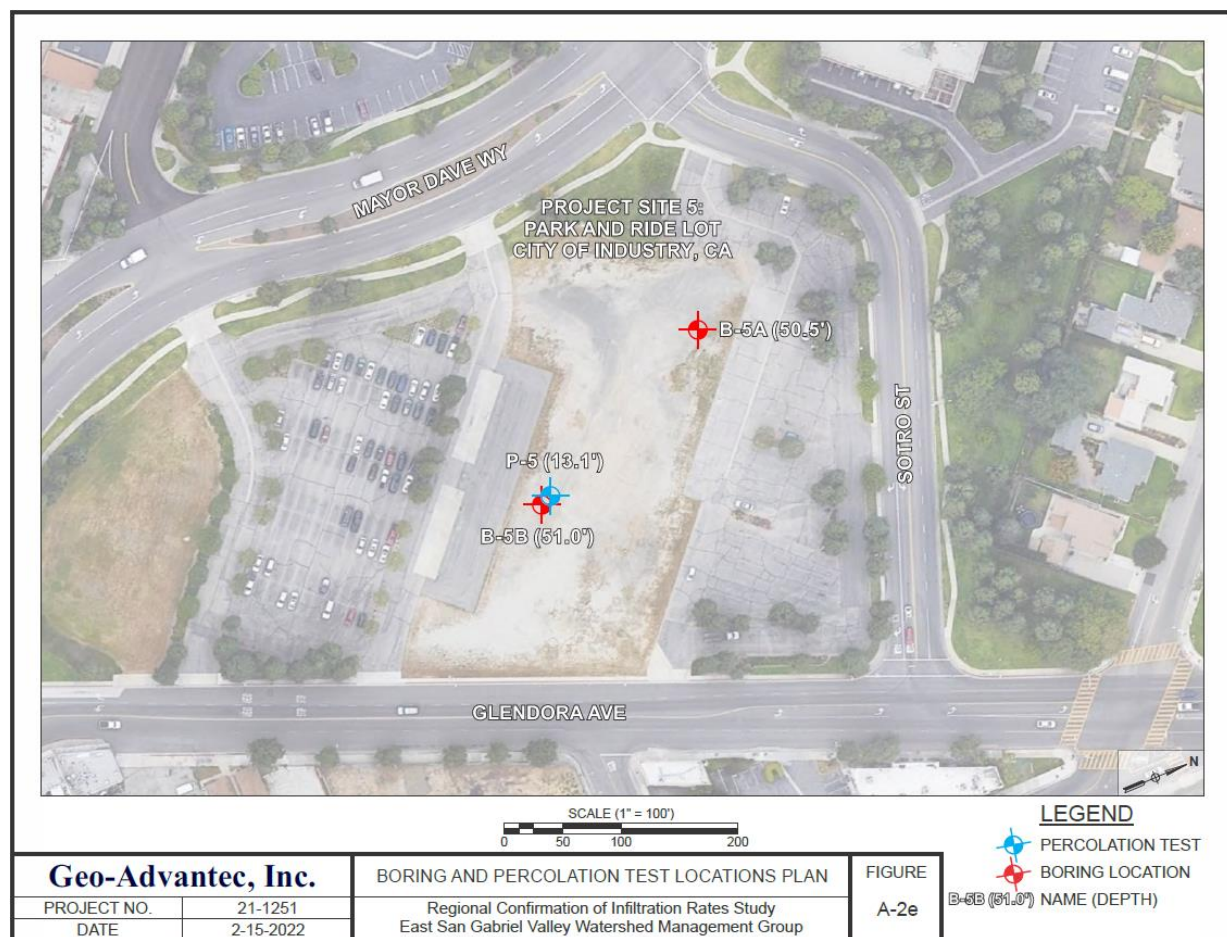
**Figure 19. Park and Ride Lot, City of Industry Boring and Infiltration Locations**

Potential boring and infiltration testing locations are shown in **Table 20** and on **Figure 19**.

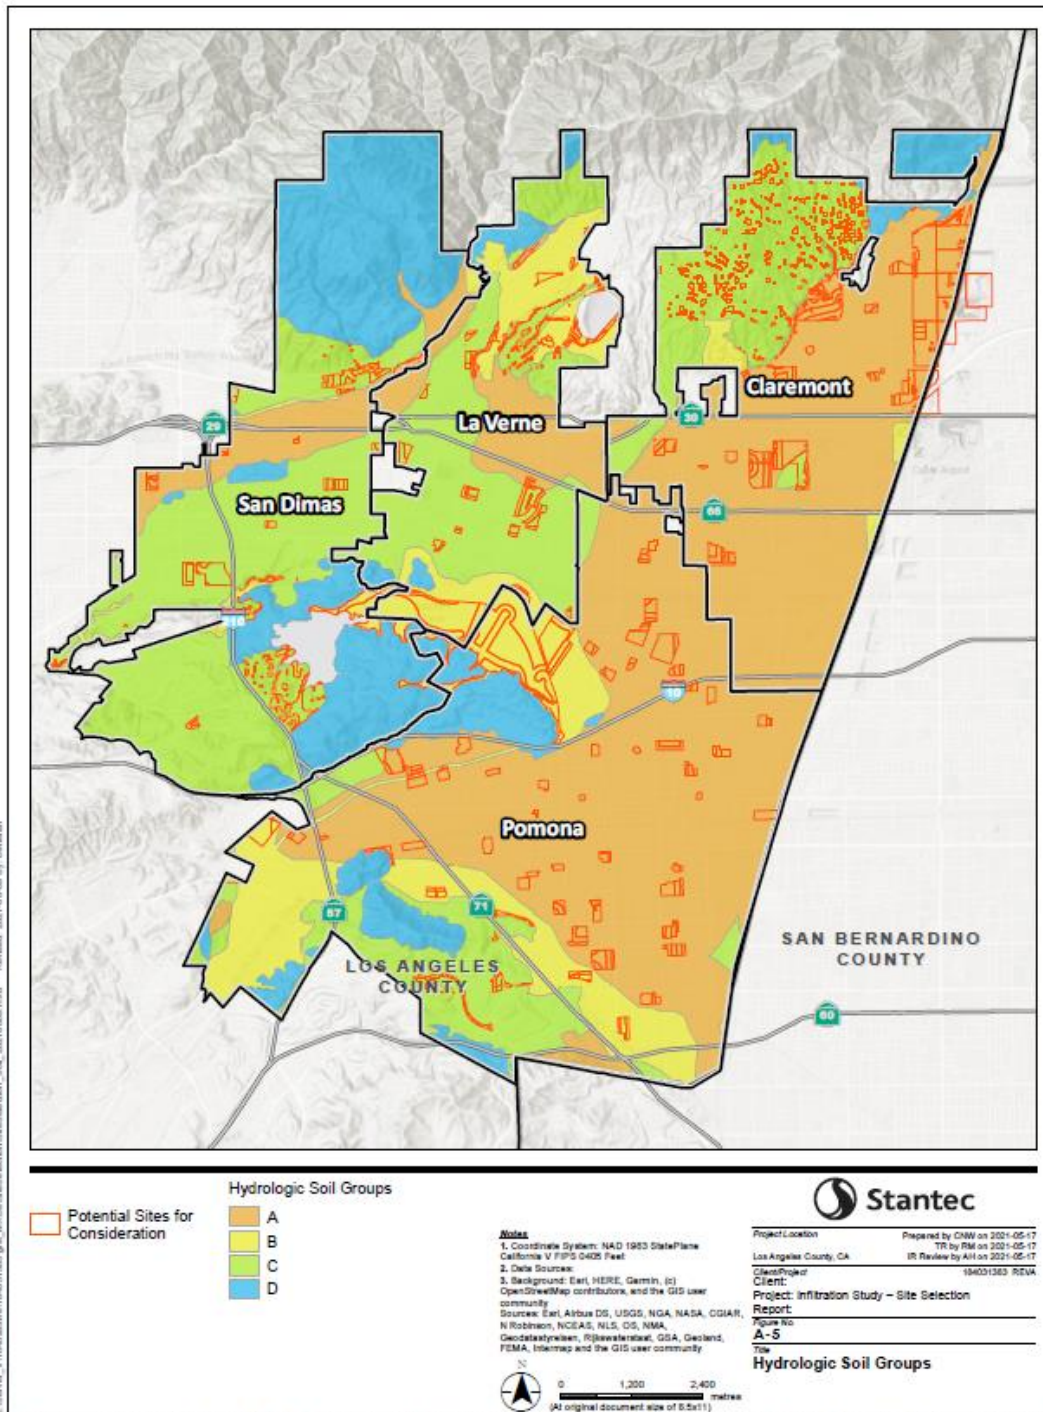
## A.5 Hydrologic Soil Groups Map
